Airfield Pavement Condition Survey
For
Ignace Municipal Airport
Ignace, Northern Ontario

4.0 CONDITION SURVEY

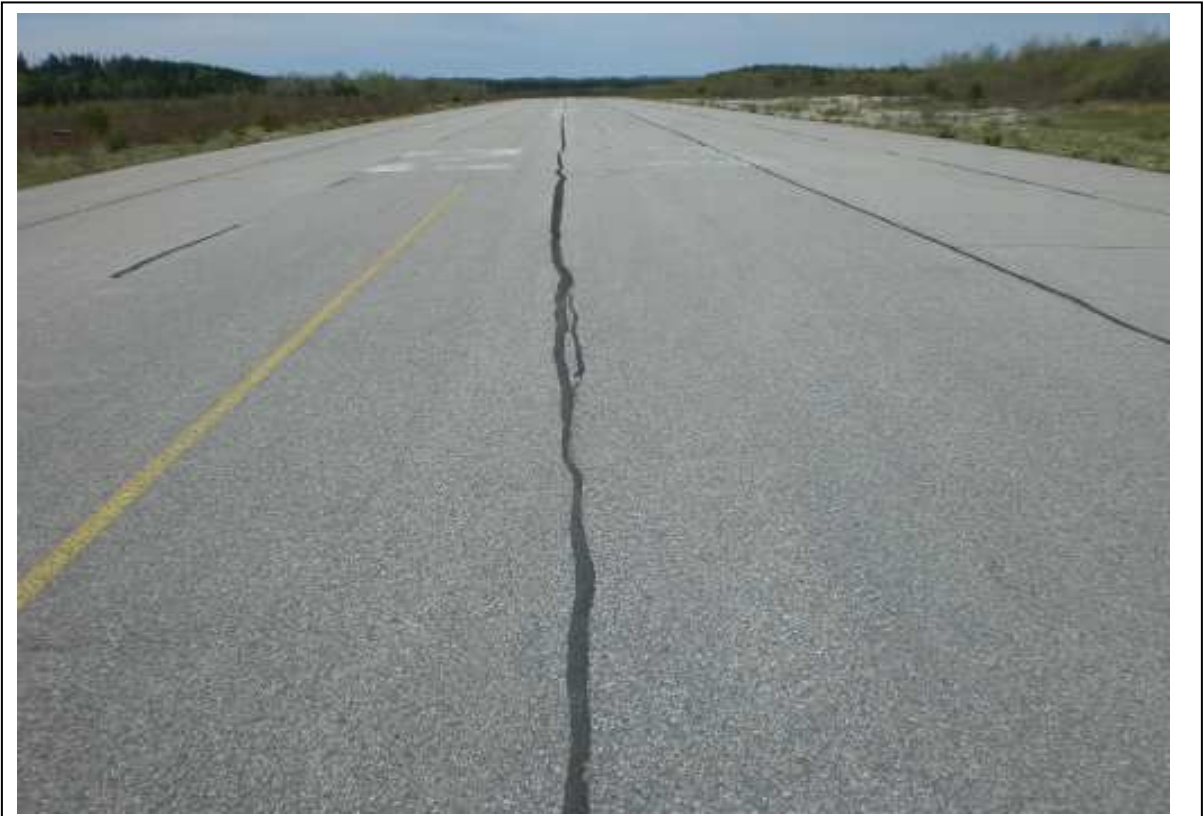
Main Runway rated in a 'good condition' as shown on Photo Nos. 1 to 3.

Photo No. 1 Runway 05-23 – Longitudinal cracking (sealed)

Year	Activity	Budget Estimate (\$)
Runway 05-23 Year 2008 Year 2010-2013*	Rout and Seal Cracks Overlay 50 mm of HMAC	\$5,000 \$223,000
Taxiway Alpha Year 2008	Pulverize existing asphalt Add 100 mm of Granular A Overlay 80 mm of HMAC	\$68,500
Main Apron Year 2008	Pulverize existing asphalt Add 100 mm of Granular A Overlay 80 mm of HMAC	\$110,000
Totals		\$406,000

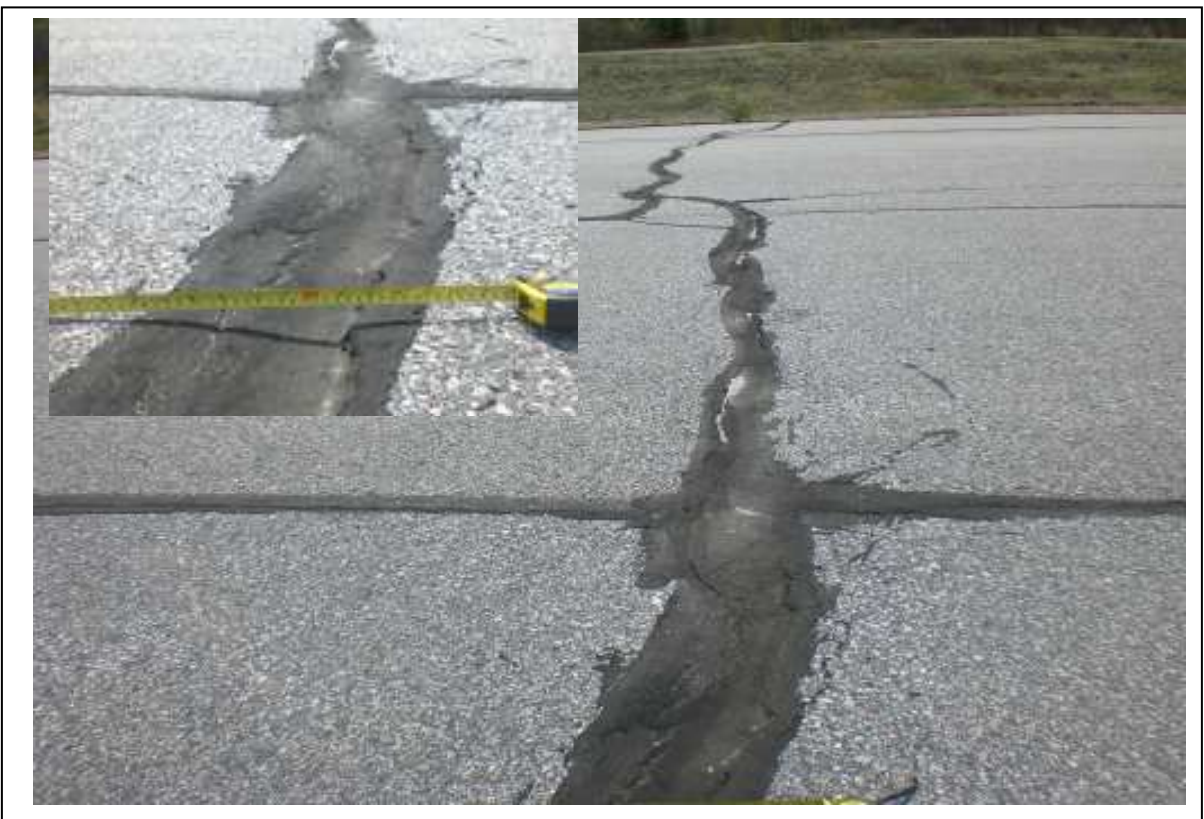
Photo No. 2 Runway 05-23- Severe transverse cracking (sealed) with subgrade settlement.

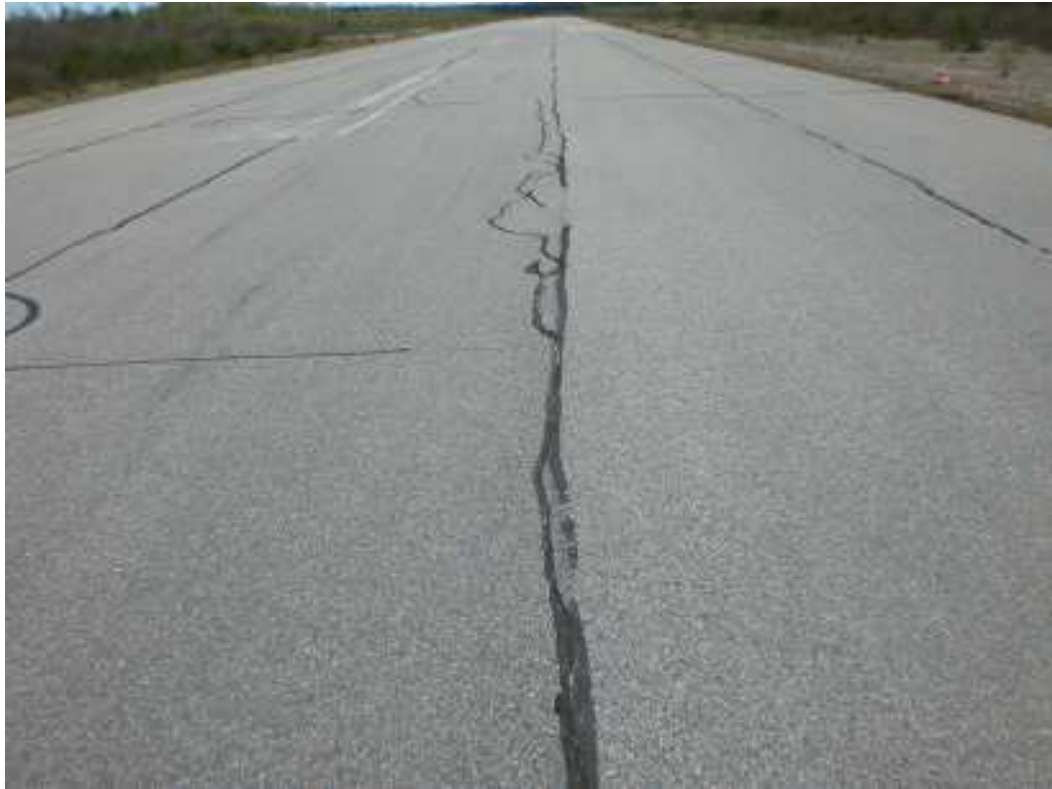
Photo No. 3 Runway 05-23 – Typical surface defects

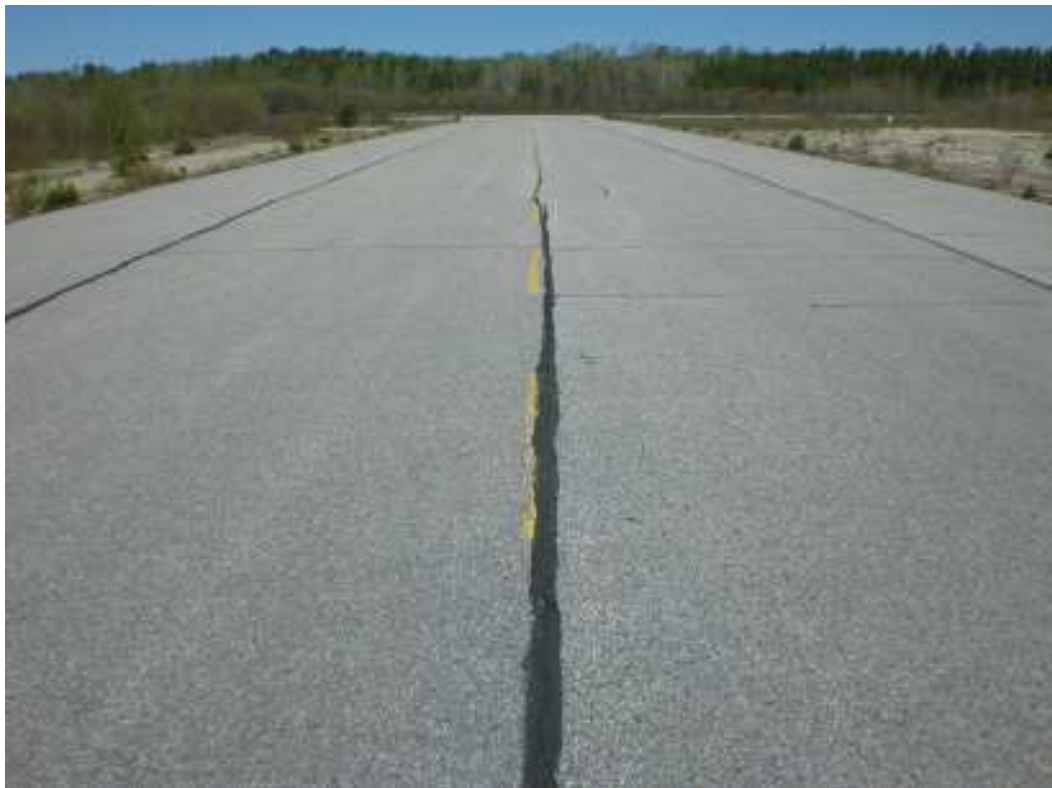
Main Taxiway rated in a 'fair to poor condition' as shown on Photo Nos. 4 and 5.

It is our opinion that the pavement of Taxiway and the Main Apron are experiencing significant distress and some form of rehabilitation is now required. If nothing is done at the airport, the existing cracks will continue to propagate and deteriorate causing an increasing Foreign Object Damage (FOD) hazard.

Photo No. 4 Taxiway - Longitudinal cracking (sealed)

As an alternative, considering site conditions, we believe that the most suitable method of rehabilitation of Taxiway and Apron would be in-place pulverization of the asphalt and mixing with the existing granular base. The exposed granular base could then be regraded / reshaped to allow for grade adjustments, followed by placement of a minimum 100 mm of Granular A base and 80 mm of new HMAC placed in two lifts. This process would eliminate the potential for reflection cracking of the existing crack pattern through the new asphalt (compared to simply providing an overlay).

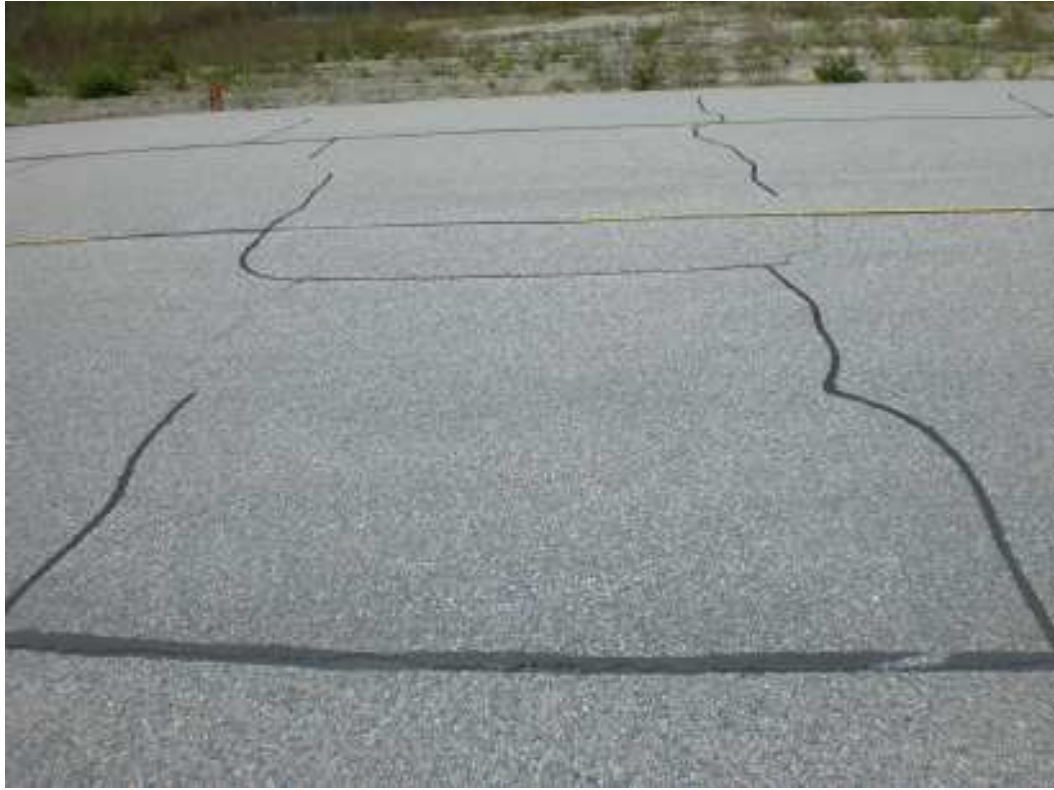
Photo No. 5 Taxiway – Typical surface defects, (sealed block cracks)

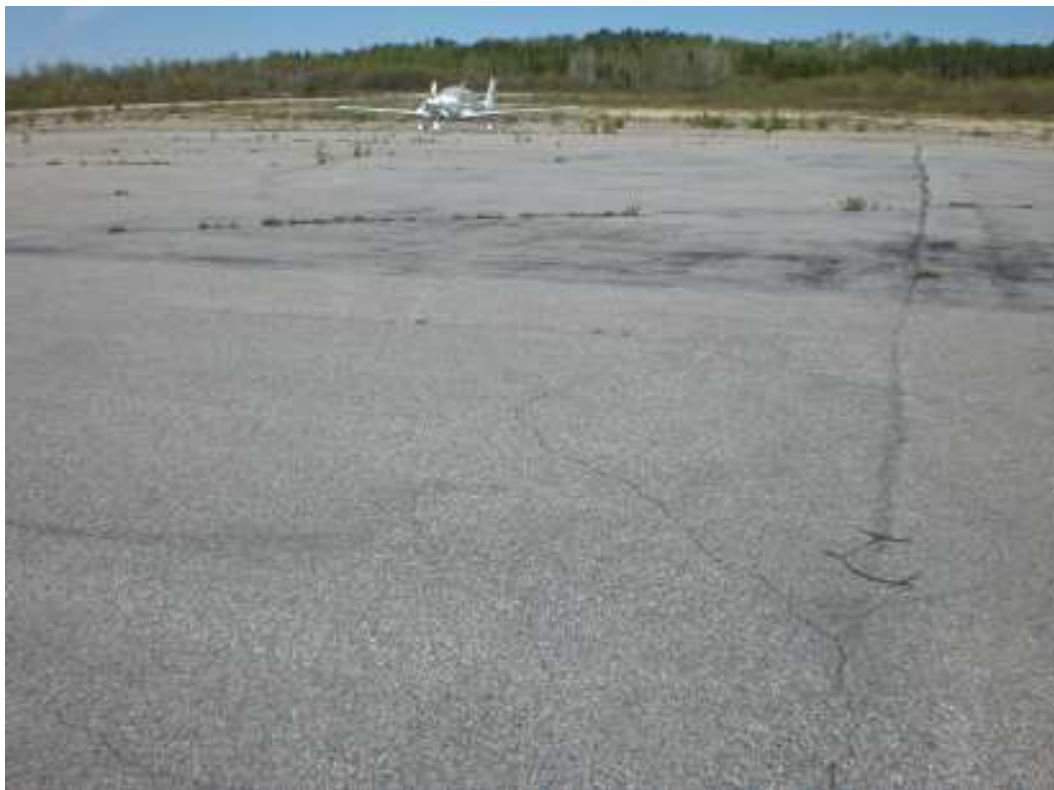
Main Apron rated in a 'poor condition' as shown on Photo Nos. 6, 7 and 8.

Photo No. 6 Apron – General View

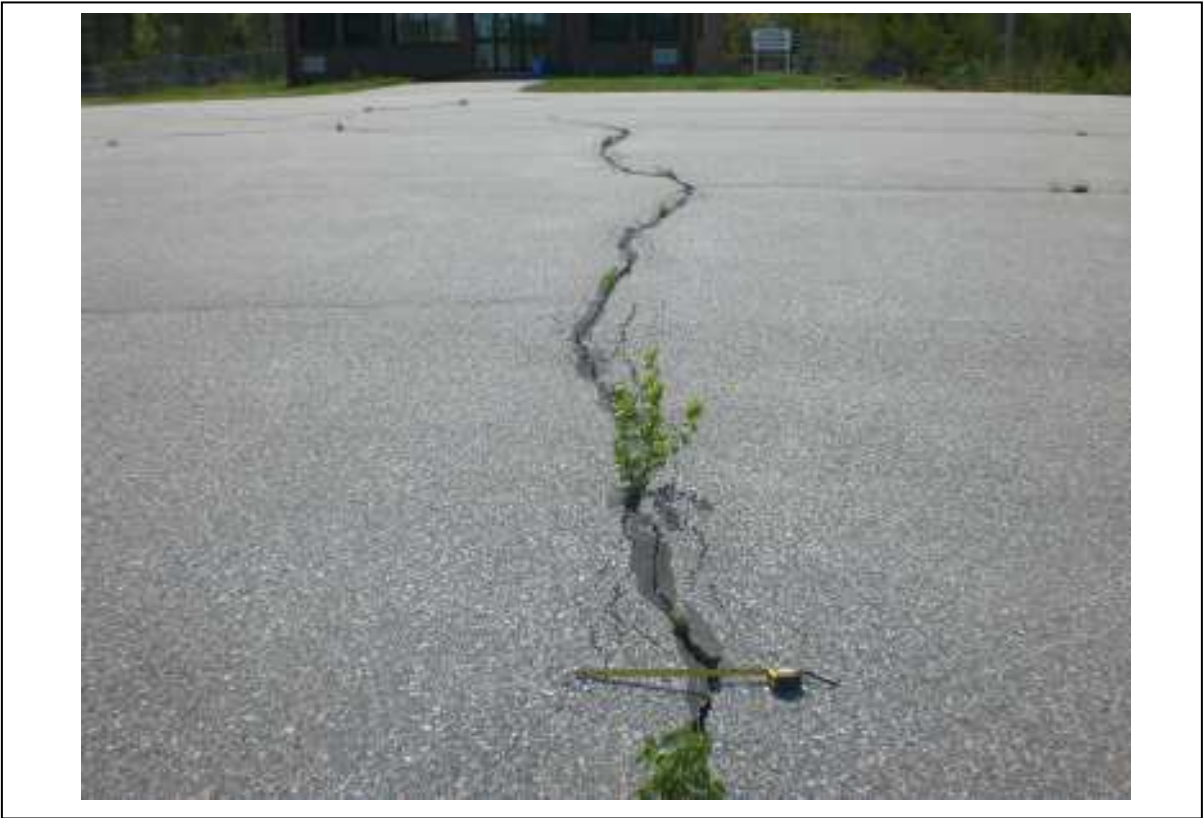
Photo No. 7 Apron – Transverse cracking. (severe)

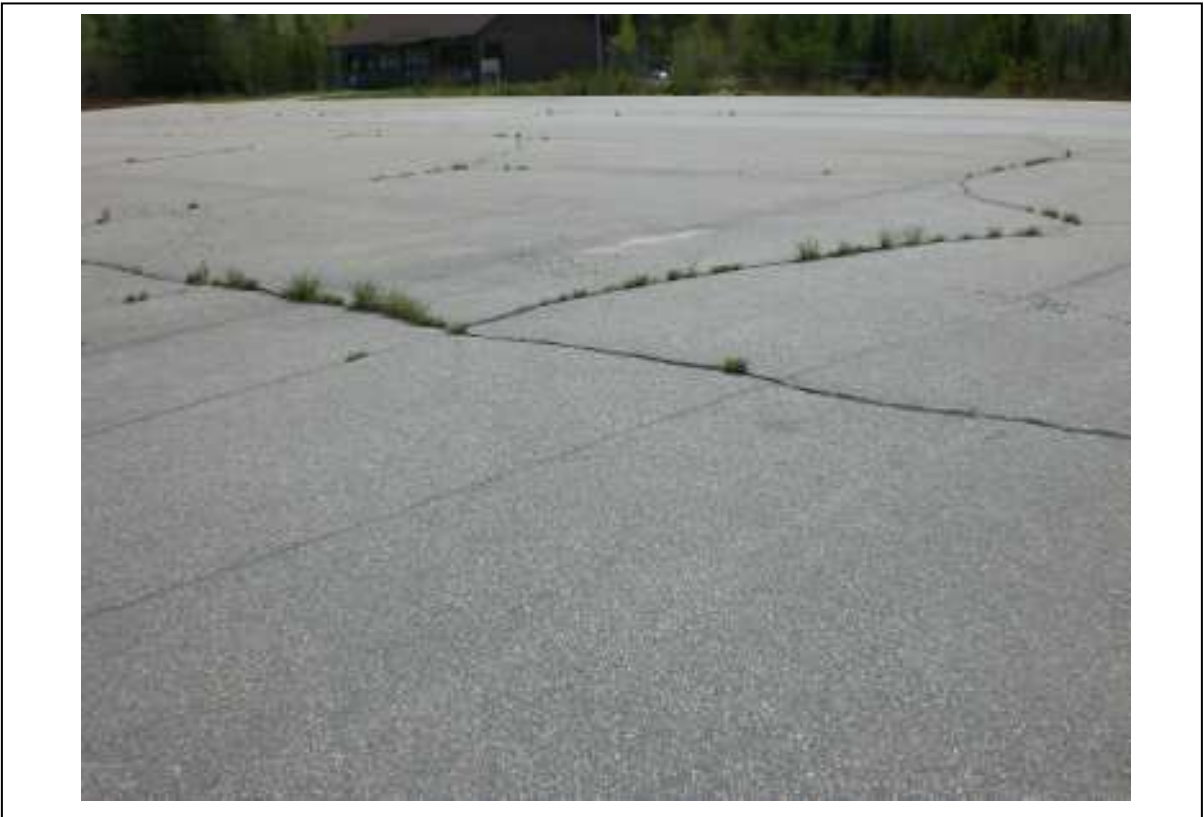
Photo No. 8 Apron – Typical surface defects.
