PINE STREET CULVERT BRIDGE AND PEDESTRIAN WALKWAY

**PUBLIC INFORMATION SESSION
AUGUST 24, 2022 6:00 – 8:00 pm
IGNACE SILVER TOPS, 300 PINE ST.**

Presentation by JML Engineering

Culvert Inspections At Pine Street

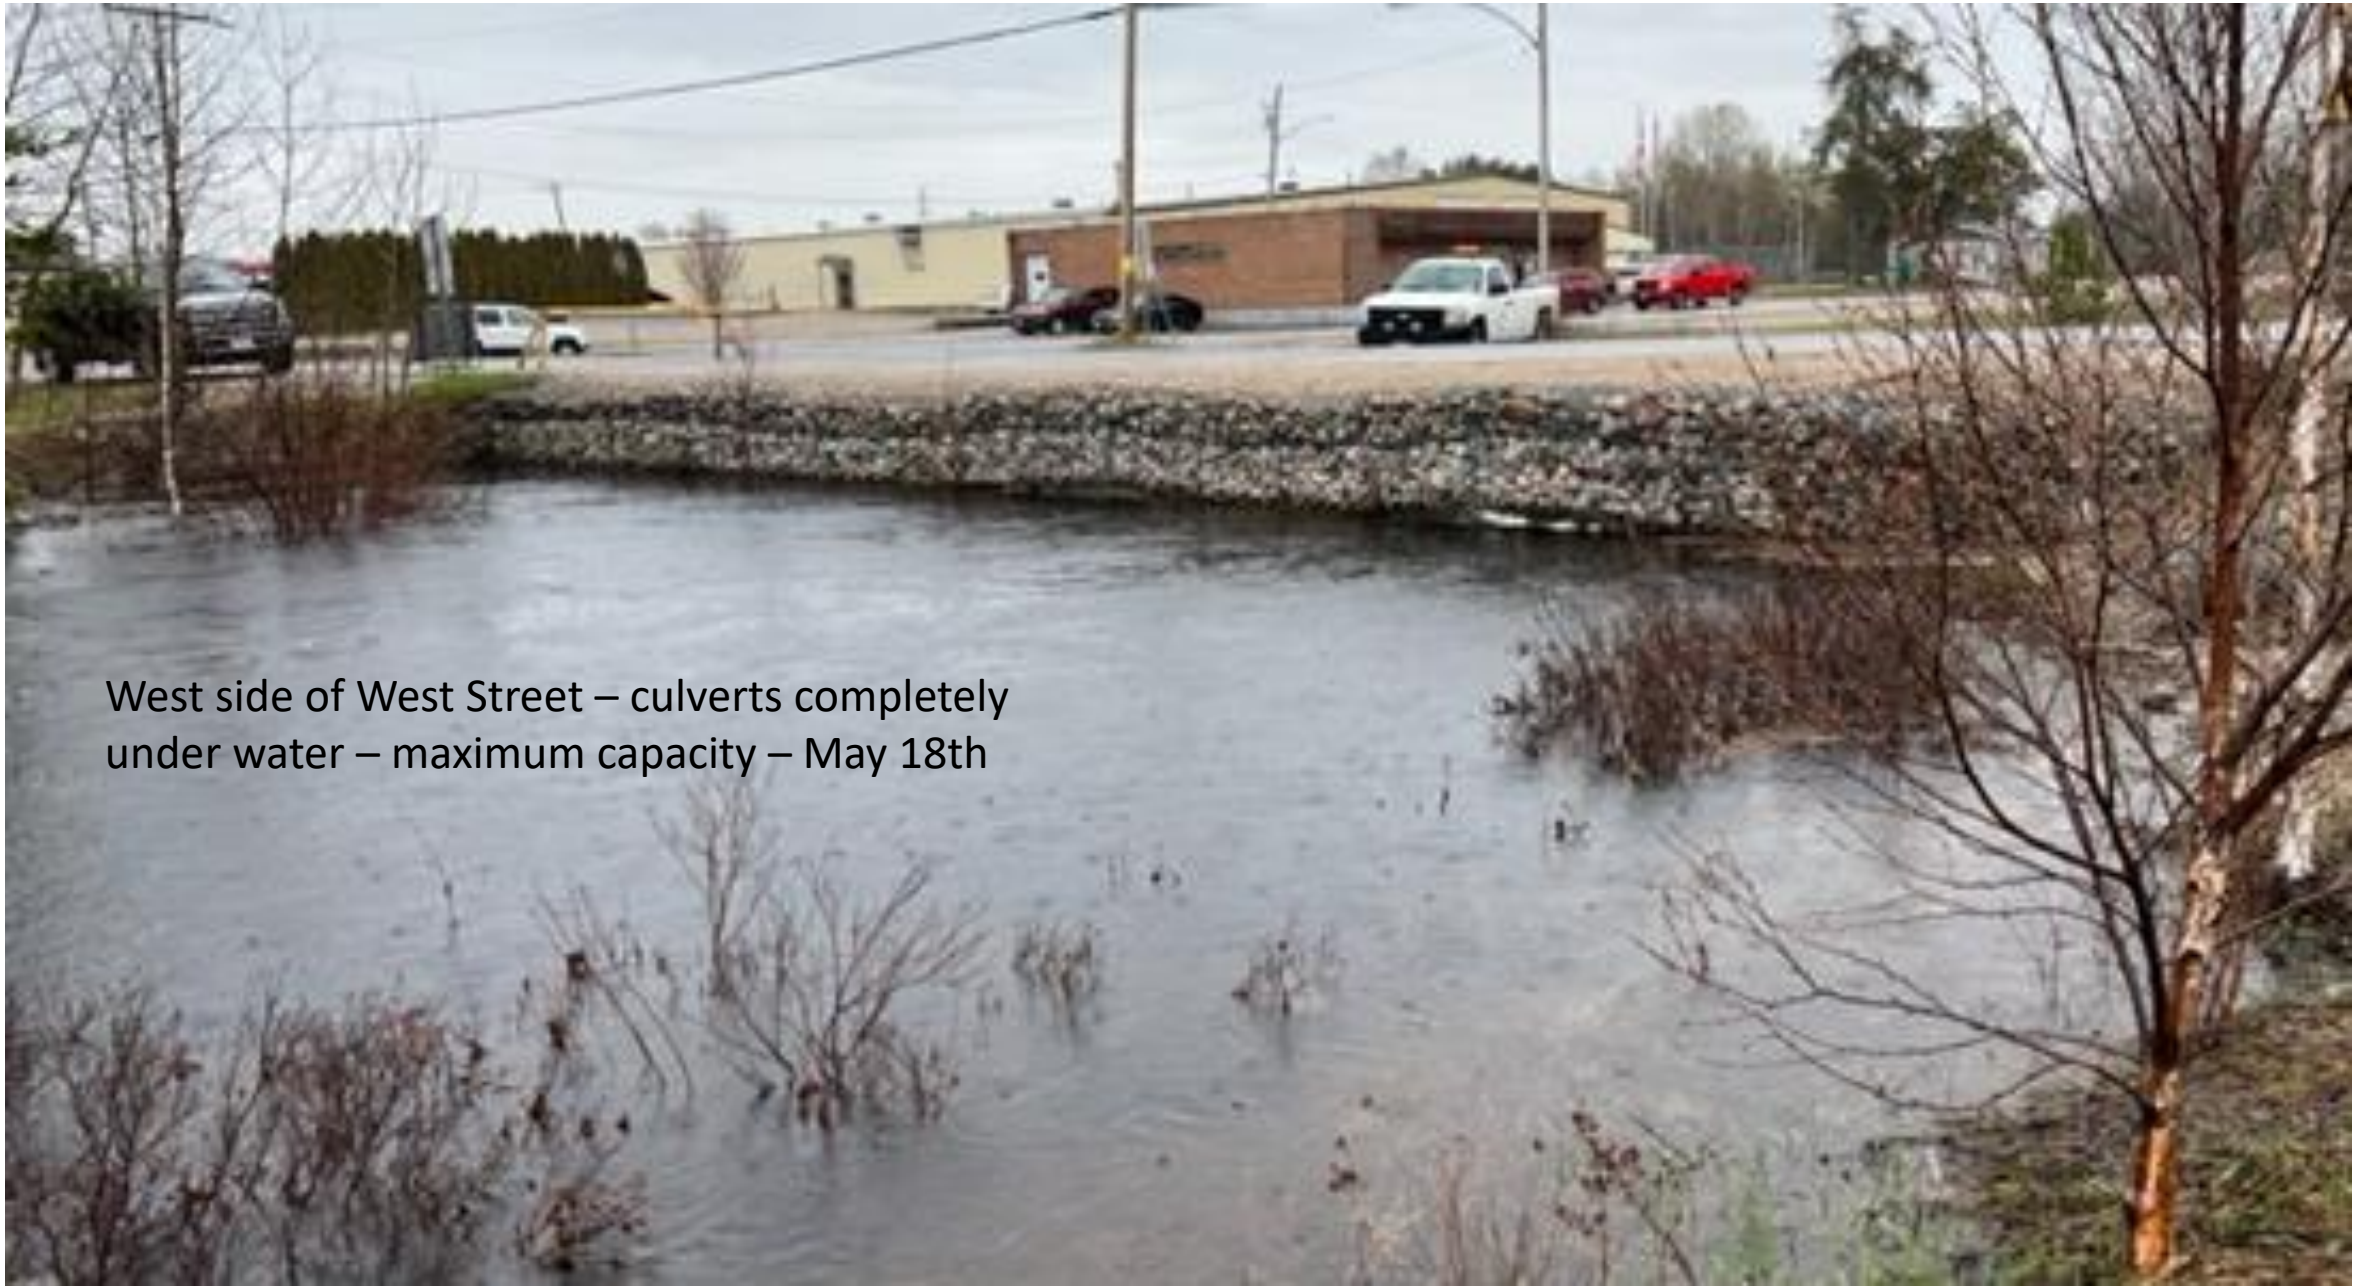
West side of West Street – culverts completely under water – maximum capacity – May 18th

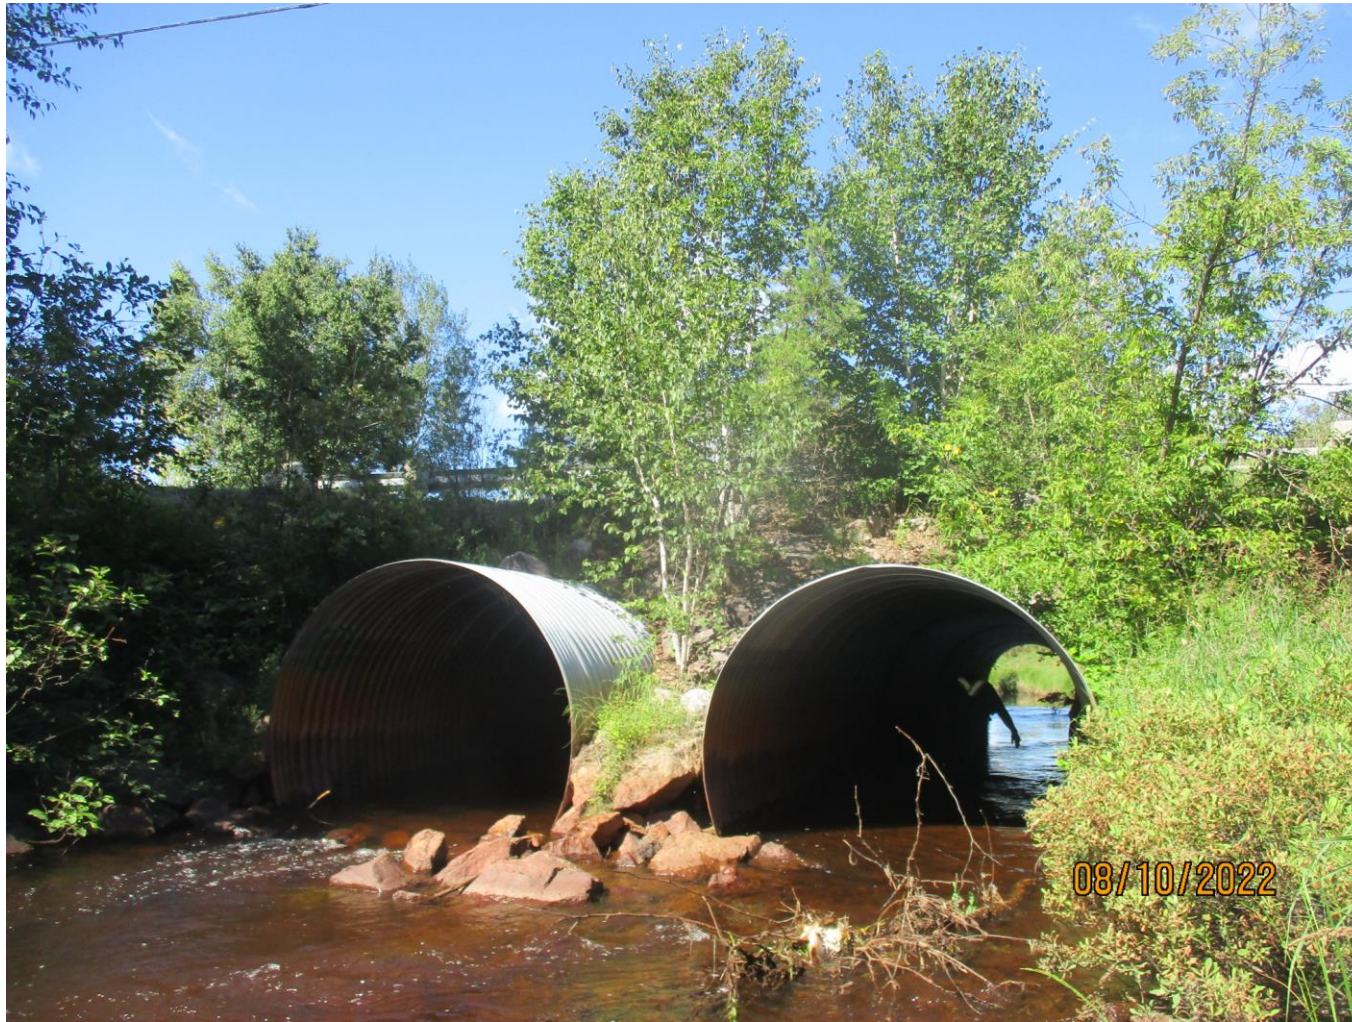
Description:
Pine Street Bridge Culverts

During the culvert inspections at Pine Street, our field crew observed significant structural deficiencies along several sections of both barrels:

- Over ten (10) holes of various sizes were observed near the waterline at both sides of the two barrels, with holes in the barrel ranging up to 200 mm wide and 300 mm tall.
- Some of the voids measured behind the culvert at the holes were over 500 mm deep.
- Over ten (10) linear tears (resembling a zipper line) were observed near the waterline at both sides of the two barrels at different locations, with the longest crack over ten (10) meters in length, and three of the long cracks directly beneath the roadway.
- In between the ‘zipper’ tears, are similar deficiencies of a lesser level of deterioration, but these areas are easily punctured by tapping with a hammer.
- The level of deterioration observed appears to have occurred over several years.
