PINE STREET CULVERT BRIDGE AND PEDESTRIAN WALKWAY

**PUBLIC INFORMATION SESSION
AUGUST 24, 2022 6:00 – 8:00 pm
IGNACE SILVER TOPS, 300 PINE ST.**

Presentation by JML Engineering

Culvert Inspections At Pine Street

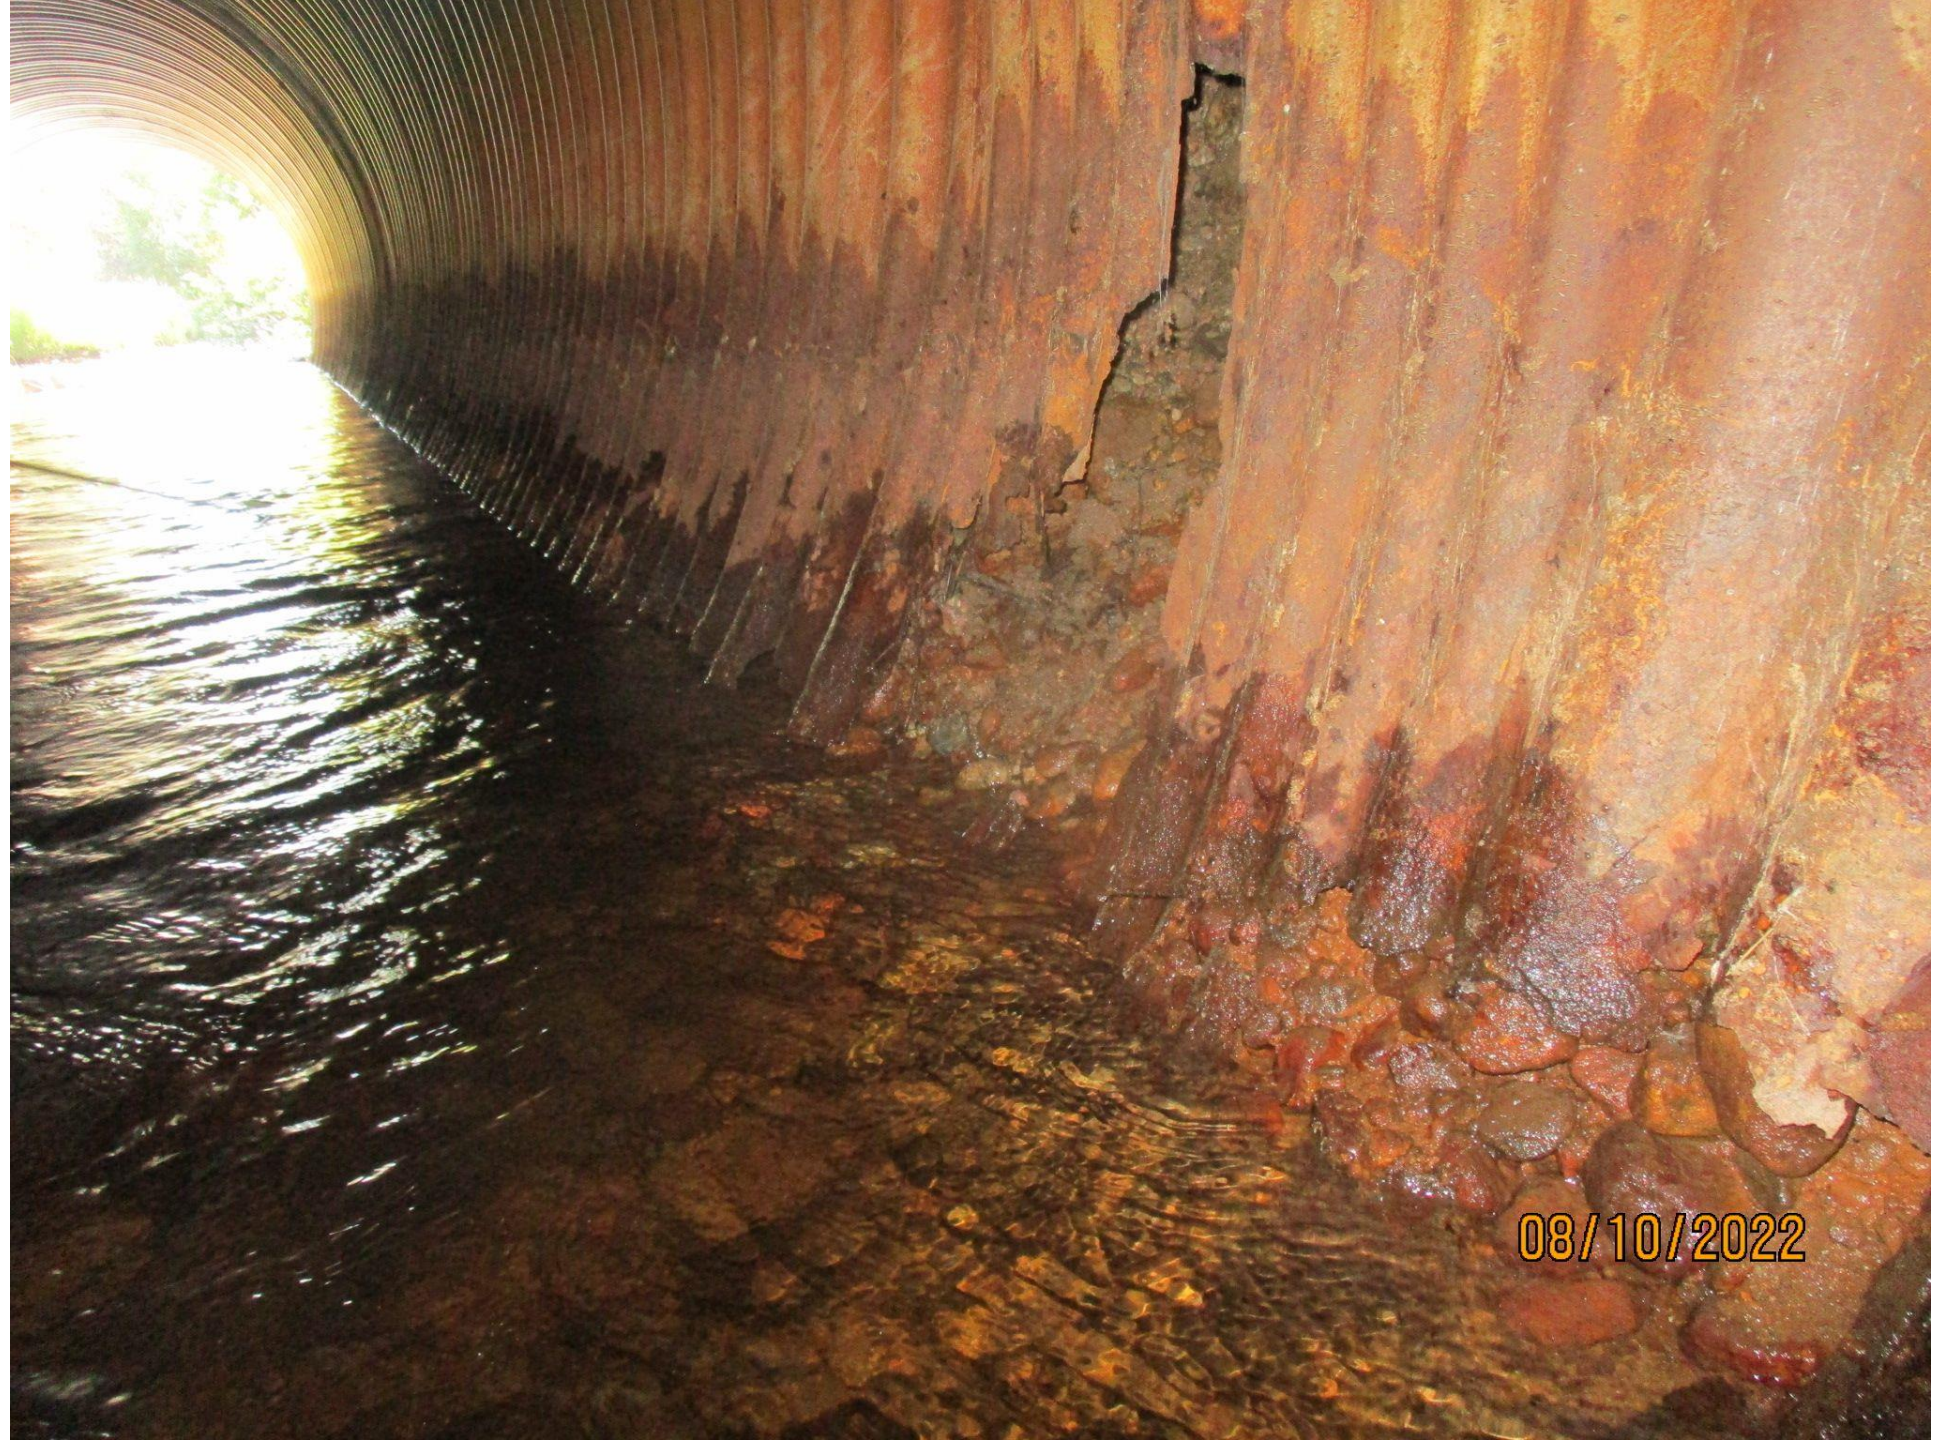
During the culvert inspections at Pine Street, our field crew observed significant structural deficiencies along several sections of both barrels:

- Over ten (10) holes of various sizes were observed near the waterline at both sides of the two barrels, with holes in the barrel ranging up to 200 mm wide and 300 mm tall.
- Some of the voids measured behind the culvert at the holes were over 500 mm deep.
- Over ten (10) linear tears (resembling a zipper line) were observed near the waterline at both sides of the two barrels at different locations, with the longest crack over ten (10) meters in length, and three of the long cracks directly beneath the roadway.
- In between the ‘zipper’ tears, are similar deficiencies of a lesser level of deterioration, but these areas are easily punctured by tapping with a hammer.
- The level of deterioration observed appears to have occurred over several years.

There is a strong possibility of either a sudden collapse to a sidewall section at one of the culvert walls, or a sudden settlement of the roadway above the culverts where voids of unknown size and location exist.

Based on the size and number of holes observed and the measured deep voids, combined with the large lengths of corroded and/or failed steel at the waterline at both barrels, JML Engineering recommends the Township consider closing the road above the Pine Street twin culverts to all vehicle traffic as soon as possible.

Monitoring of the crossing should continue until a rehabilitation solution is designed and implemented. A feasibility study should be considered to explore rehabilitation/replacement options to determine the most cost effective solution to reinstate the integrity of this crossing.
